Sanitizing UV Light for Ice Machines

TECHNICAL BULLETIN

Field Study Confirms **Fresh-Aire ICE UV™** Reduces Biological Contamination In Ice Machines

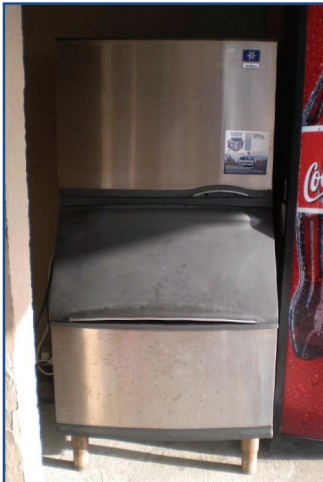
ICE MACHINE A
Sample JORTC-1S

BEFORE		AFTER	
Fungi	Bacteria	Fungi	Bacteria
82,000	2,300,000	10	1,400

ICE MACHINE A
Sample JORTC 2S

BEFORE		AFTER	
Fungi	Bacteria	Fungi	Bacteria
1,140,000	3,000,000	2,130	1,400

First, we took swab samples from the spray bar assembly and inside the access panel doors of the two machines and sent the samples to a certified lab for analysis. This is reported as the "Before" data in the table. Then, on the same day and without cleaning the machines, we installed the **FRESH-AIRE ICE UV™** devices in the machines. The **ICE UV** was installed exactly as displayed in the ice machine rendering on the first page.

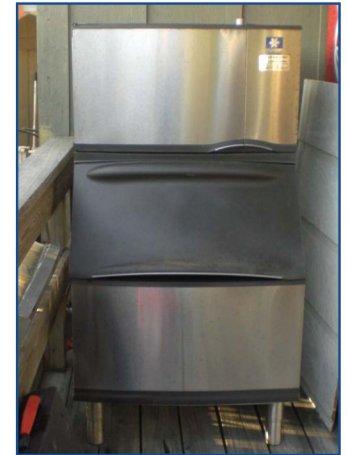
ICE MACHINE B
Sample JBT-3S

BEFORE		AFTER	
Fungi	Bacteria	Fungi	Bacteria
80	130	10	10

ICE MACHINE B
Sample JBT-4 S

BEFORE		AFTER	
Fungi	Bacteria	Fu gi	Bacteria
10,700	730,000	360	910
